ventura county california

Survey Report for Beach Erosion Control

May 1980

U.S. Army Corps of Engineers Los Angeles District

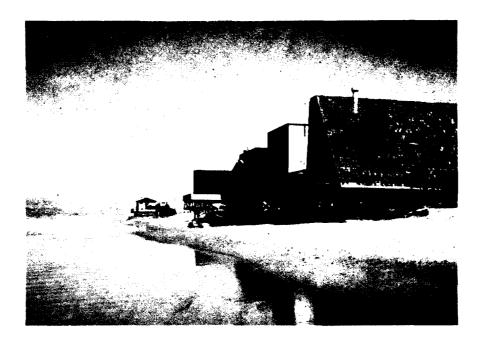
Downcoast view of groin no. 1, San Buenaventura State Beach, Mar. 15, 1978
